Bowyers Stream Spring 2013

A Catalogue of river control work carried out on Bowyer Stream Spring 2013 and issues identified from a recreational angling point of view, supported by the Waikato Regional Council Best Practice Guide Lines with the key applicable guidelines listed below;

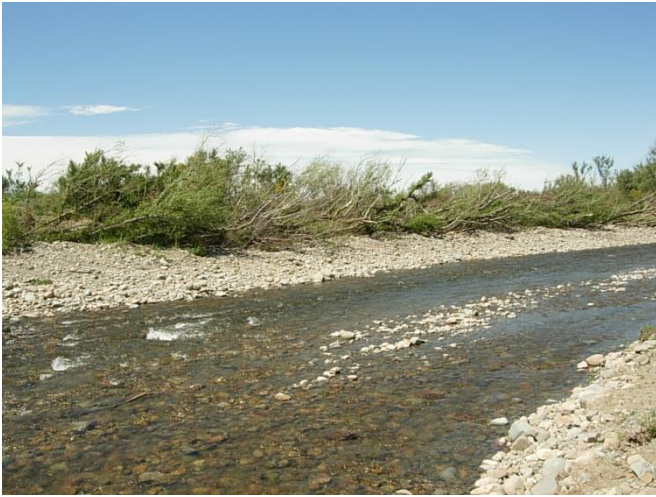
An apparently well repaired erosion area with extensive layering.

I understand that budget constraints are the reason why complete repairs aren't undertaken. Adjacent land owners are responsible for the cost of those repairs – Pic 1 would appear to be an example of where the land owner has paid for the repair. So if the land owner doesn't want to commit to the repair, then it appears these types of temporary repairs are attempted.

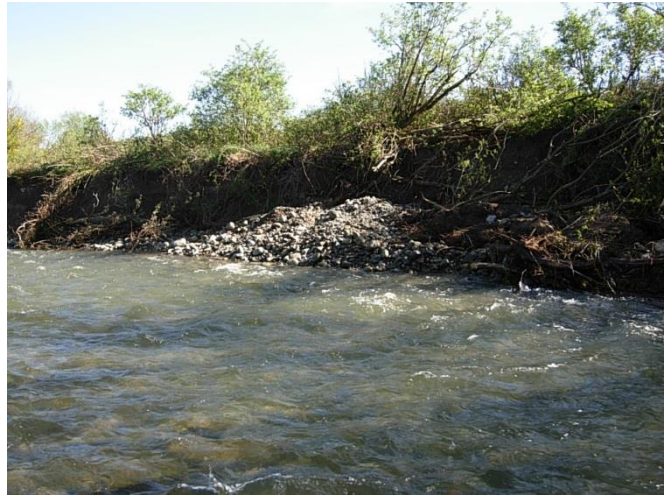
2

An extend pool area has been removed opening the bank to direct flow and faster water flows. Only a short section of bank repair work had been attempted. It's likely the work will be washed out by normal flood activity, and the pool that was in this corner has not been recreated, so a net loss to fisheries values yet little gain in erosion control! An example of work that is unlikely to meet the WRC best practice guidelines.

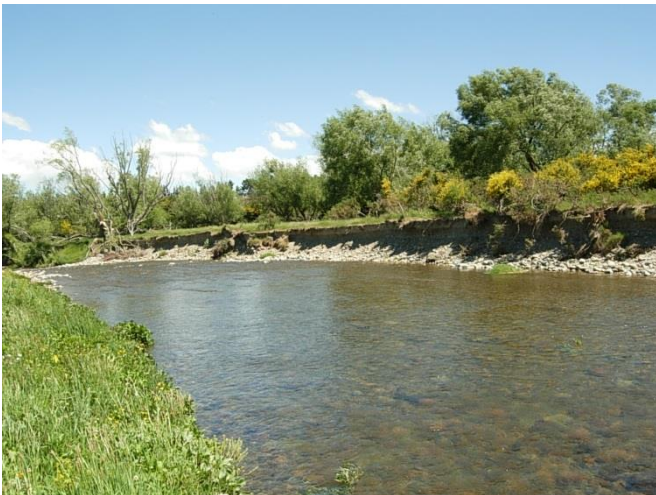
3

This section of bank has not been touched however is directly opposite picture No 1 – no poling, no layering. Demonstrates the haphazard/variable nature of the way work is applied to the stream

Left alone for nature to take its course – like it should be – the preferred approach from a recreational angling point of view and meets best practice guide 4.2.1a

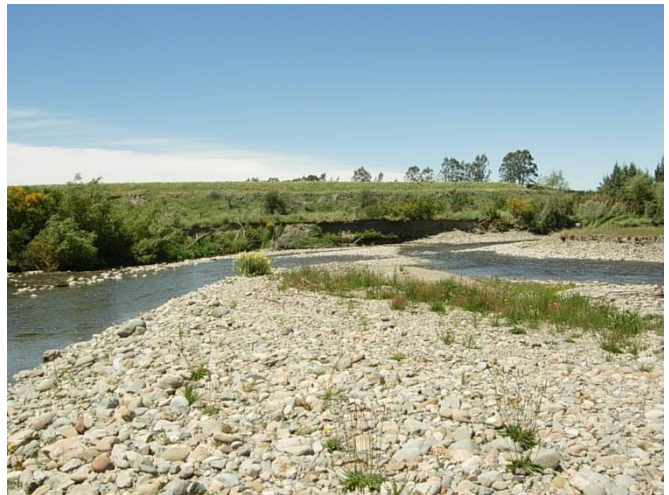
4

Another section of bank that has been eroding over a long period of time and again shows partial repairs (right hand side where gravel has been pushed against the bank) rather than a complete repair job. Left hand side indicates some diversion of water. Another example where work is unlikely to meet guidelines

It's not the first time temporary type work has been done at this location; no doubt another partial repair job will be attempted on the next visit...

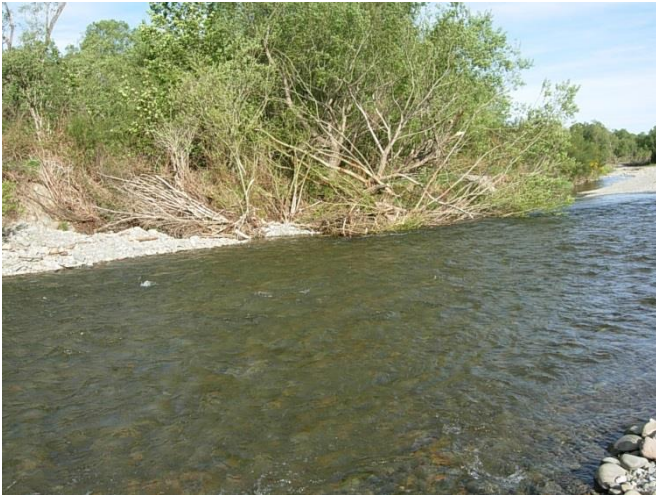
Example of other work where gravel is pushed against the bank – machinery in the water - unlikely to resist normal flood events. I can distinctly remember the pool in photo 6 getting similar treatment in a previous control effort.

Picture No 5 shows another removed about 1km below the ford

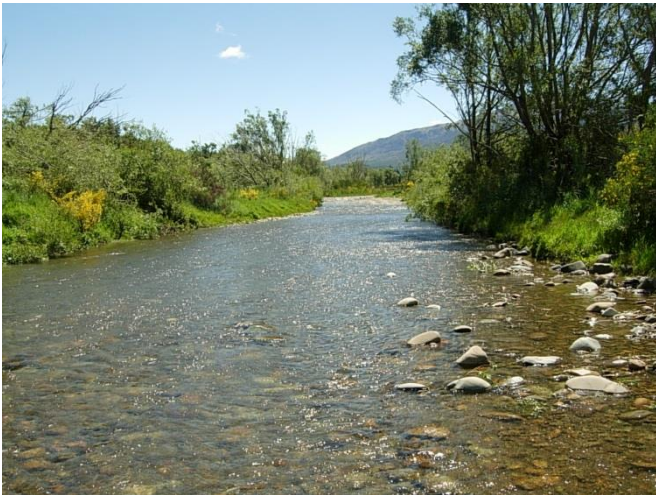
It's noticeable that a lot of cover has gone. Picture 7 – I never knew this section was straight, you couldn't see up it previously. Picture 7 – 8 note both show areas with very stable grassy banks.

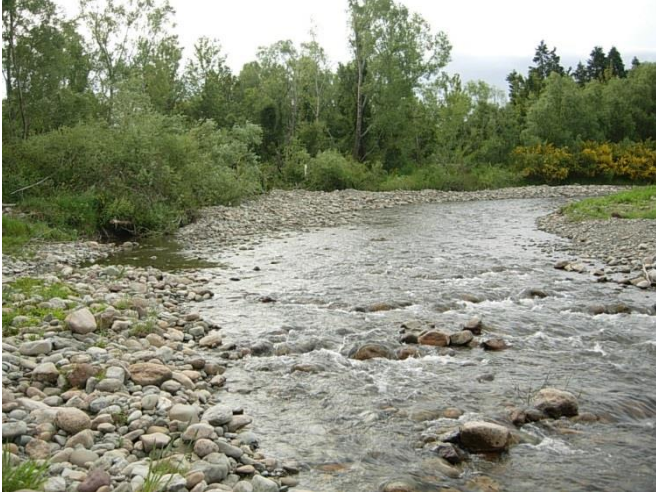
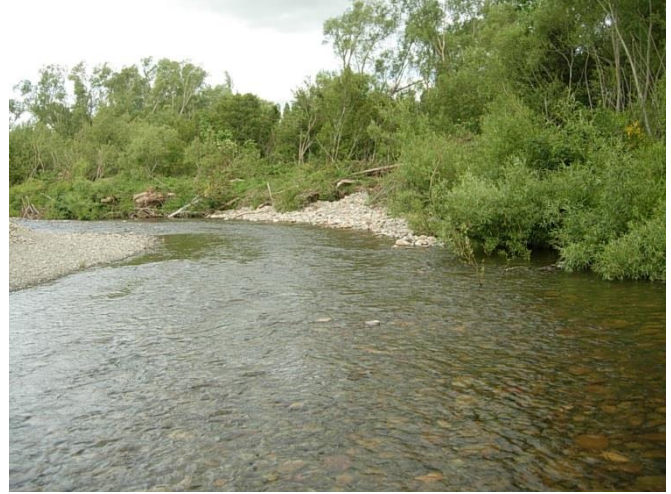
Pictures 9 & 10 are from the section above SH72 where the water flow is noticeable less as it's above several inflows

In this sections a number of corner pools have been filled with gravel;

1. Pools removed reducing trout habitat and fishing opportunity
2. River move out of shaded area – now in full sun
3. Work is temporary in nature, unlikely to survive normal flood events

Pictures 9 & 10 show the type of work carried out above 72 showing more pools removed in that area having an

even greater impact on the fishery there – Local angler reports it is no longer worth fishing in this stretch and I concur

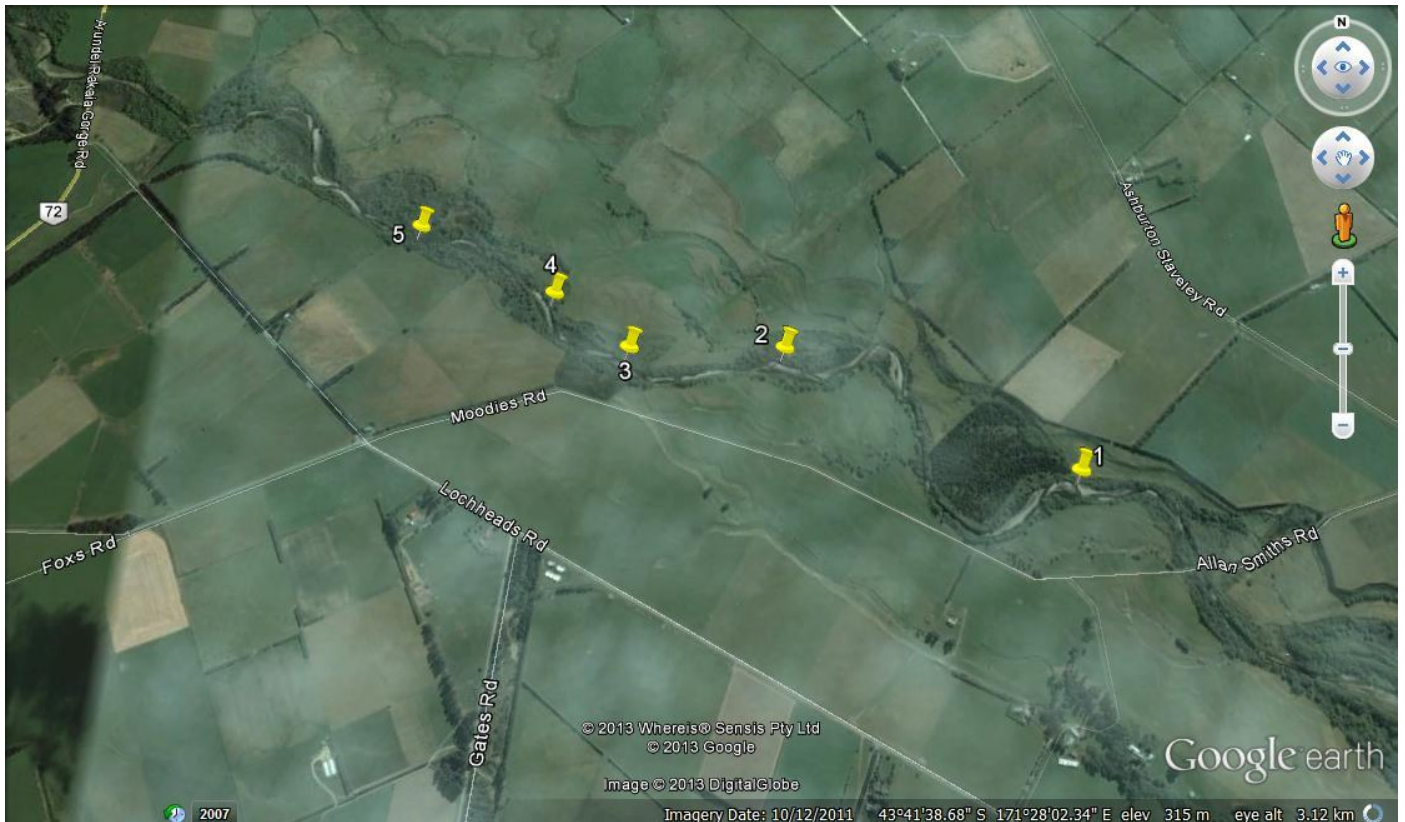
11

It's subjective as to just how many pools have been removed as a result to this work alone, it cannot be fully measured without a before and after inspection – I estimate approximately 5 have been removed from the section between the ford and 72.

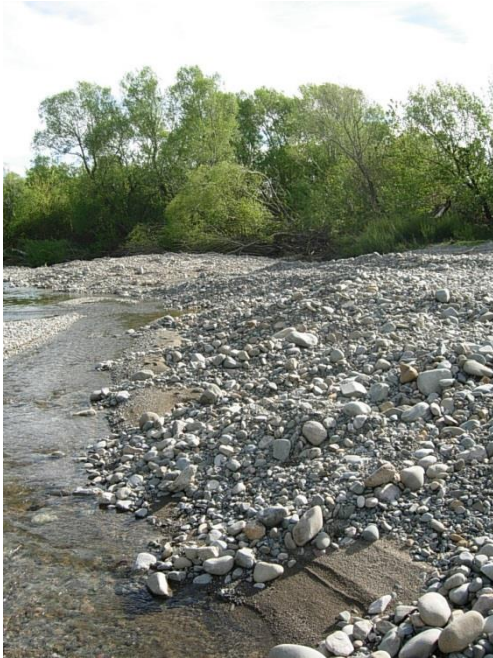
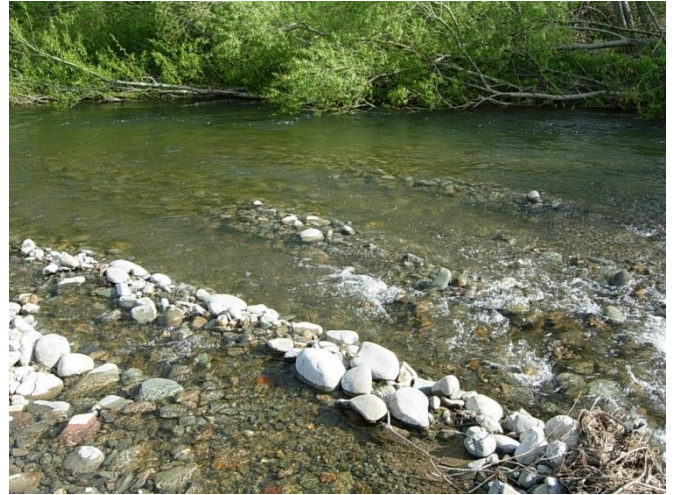
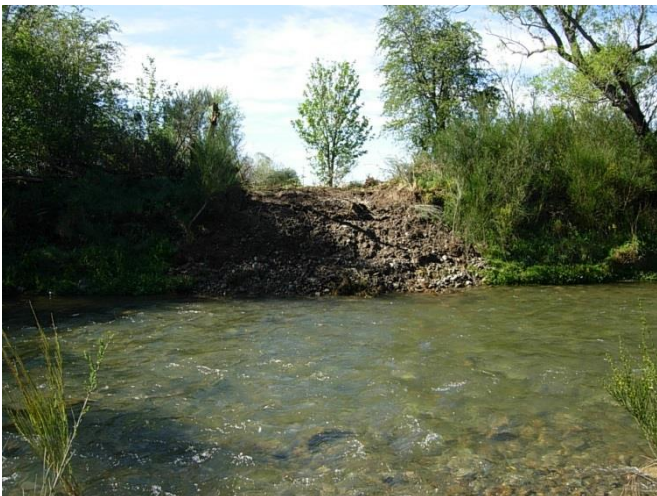
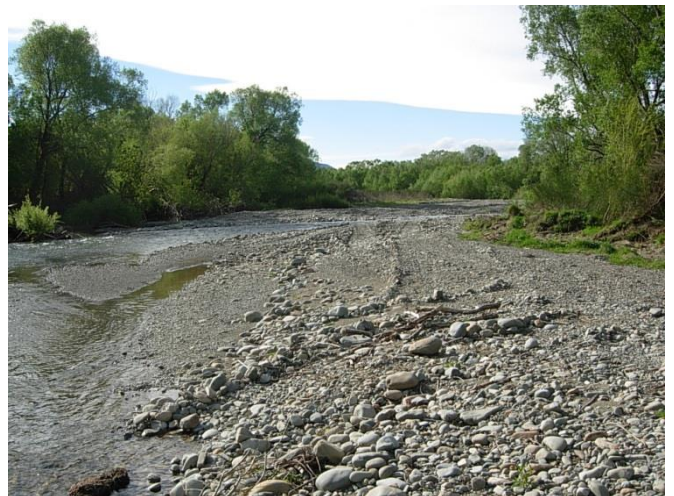
It's clear that this work required extensive use of machinery in the water to layer the willows and in places quite a lot of bank disturbance occurred

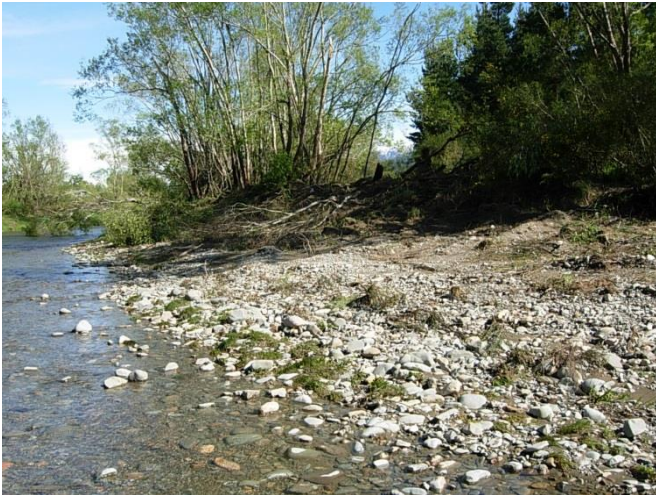
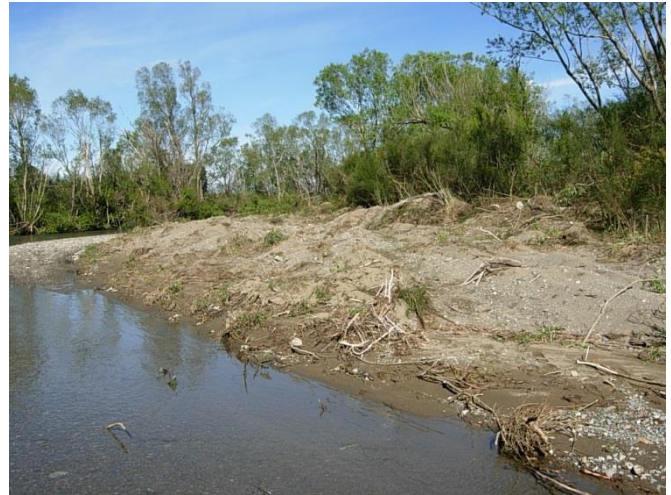
The disturbances to the banks can make for difficult walking conditions and reduces the amenity value. Pictures 16 & 17 are beside one of the best pools in the most fish part of the stream, the work was to reduce the height/build-up of the inside bank to stop it pushing the flow further against the outside bank.
