Before & After view – After the April 2014 floods most of the river control work has been washed out
1. Gravel pushed into bank, pool that's been here for years has gone!

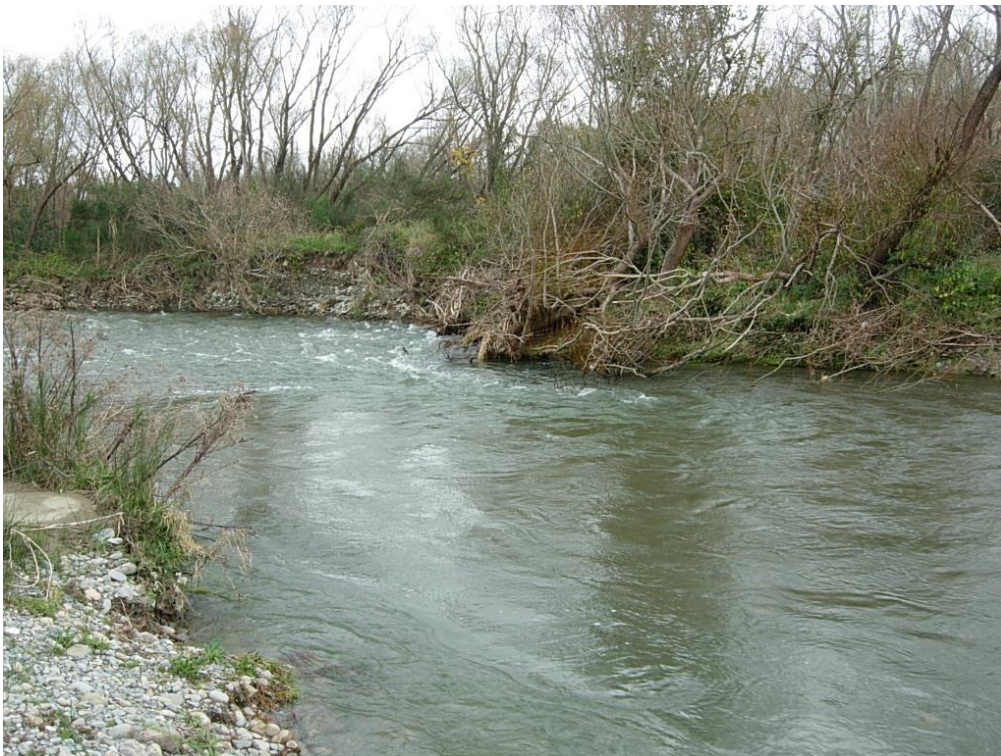
2.

The same view looking up from below, the centre of the picture is the same place. The April floods have washed out the gravel and restored the pool!

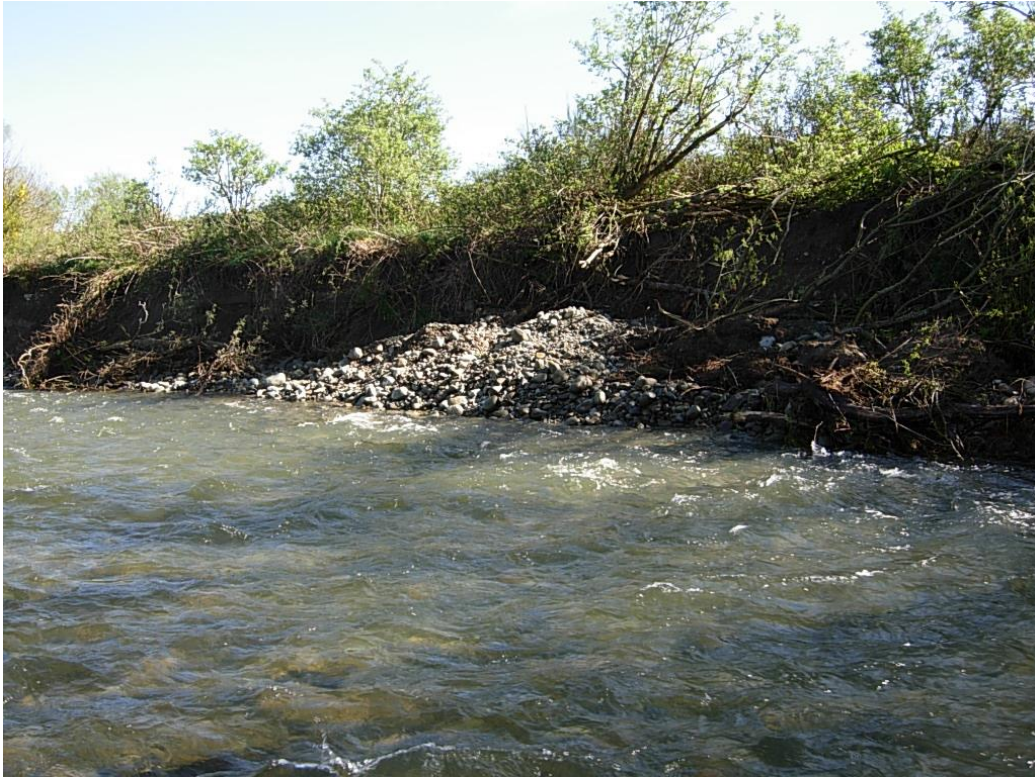
3. An extend pool area has been removed opening the bank to direct flow and faster water flows. Only a short section of bank repair work had been attempted. It's likely the work will be washed out by normal flood activity, and the pool that was in this corner has not been recreated, so a net loss to fisheries values yet little gain in erosion control! An example of work that is unlikely to meet the WRC best practice guidelines.

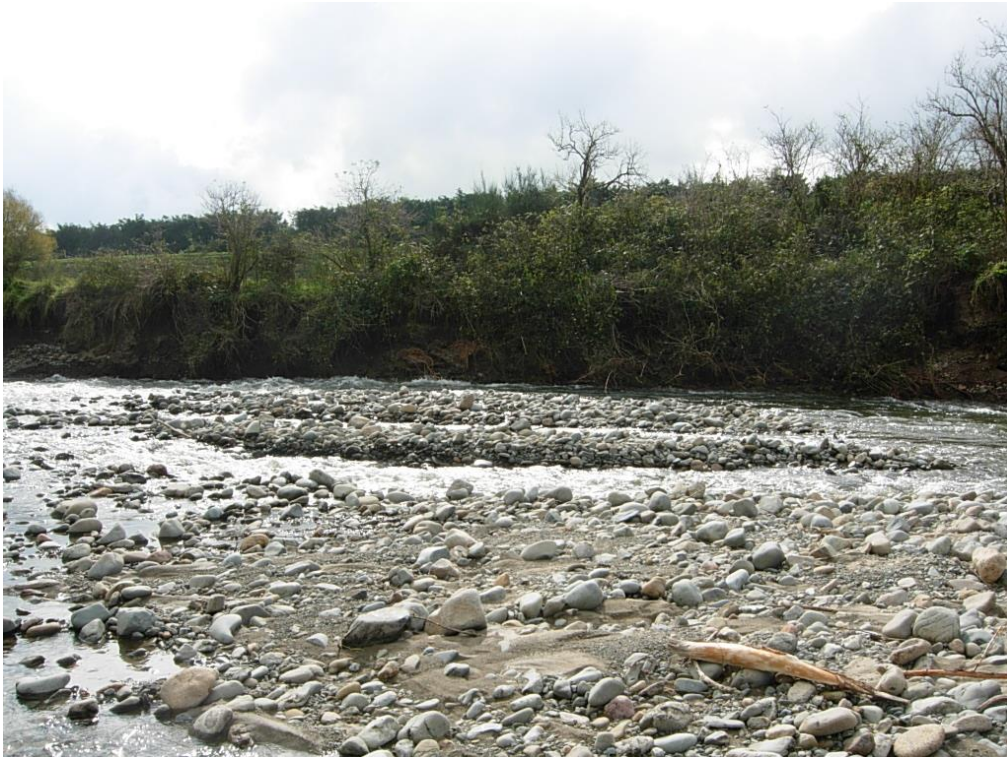
4.

April flood washed the loose layering away, exposing the bank to more erosion. Net gain for this section would appear to be more exposure to erosion risk -

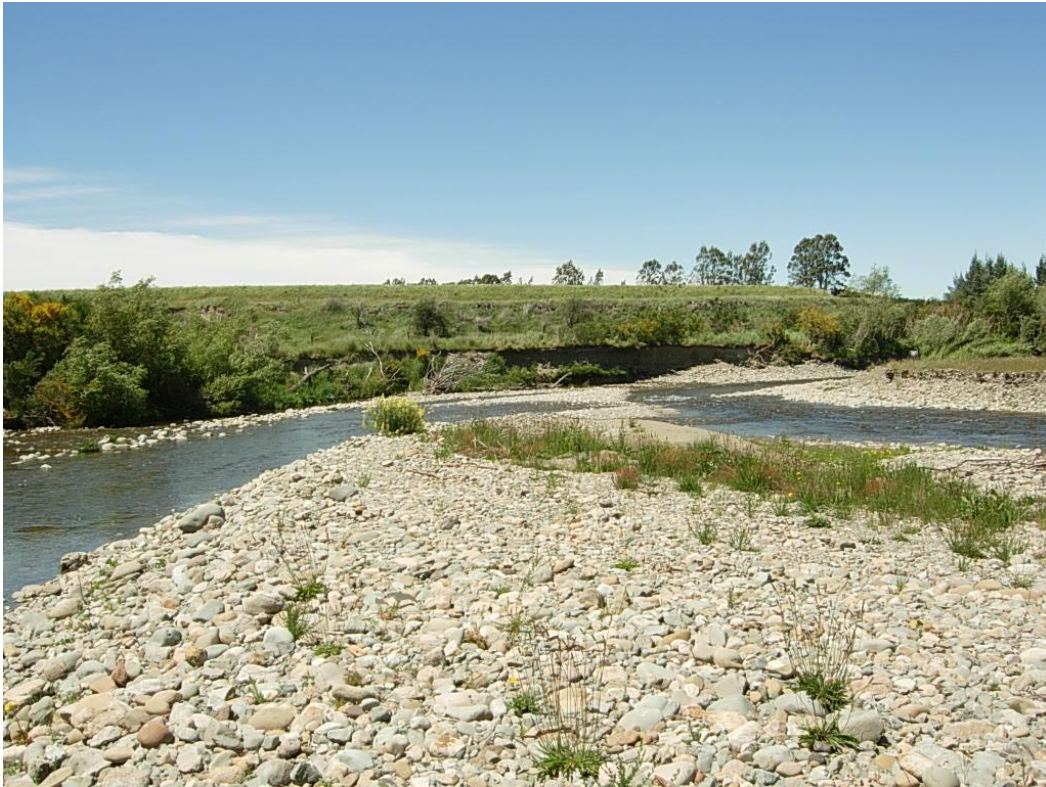
5 Partial repairs (right hand side where gravel has been pushed against the bank)

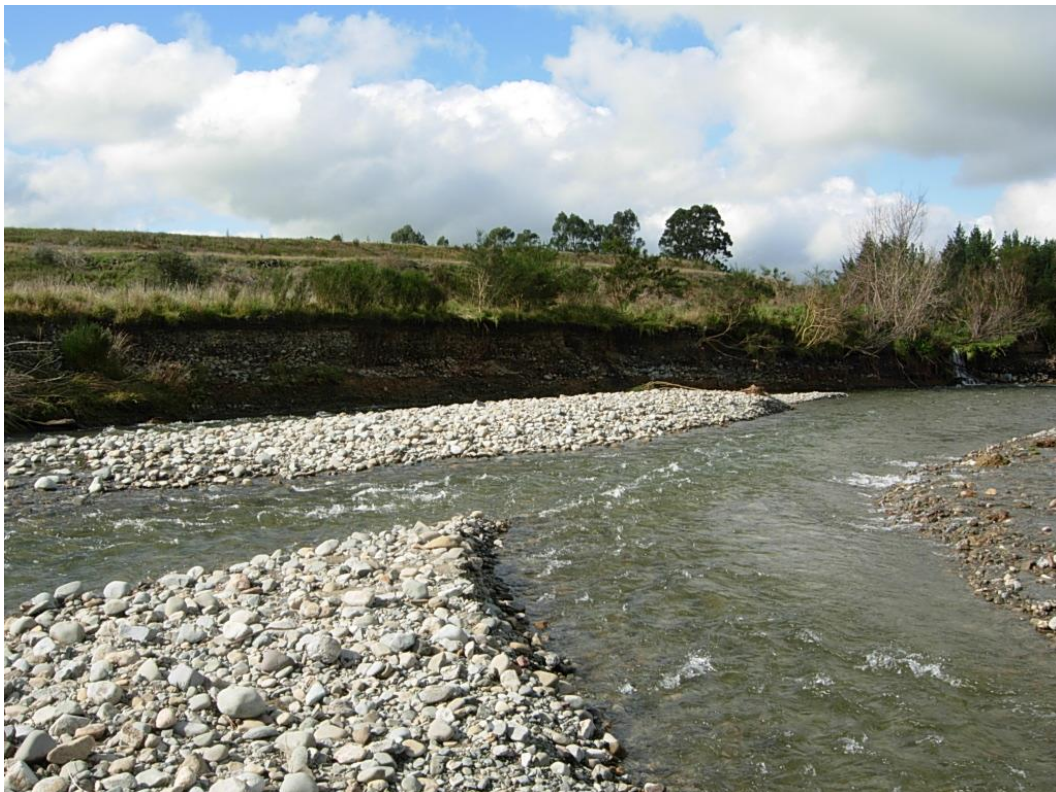
6

The same view after the April floods show the work completely removed

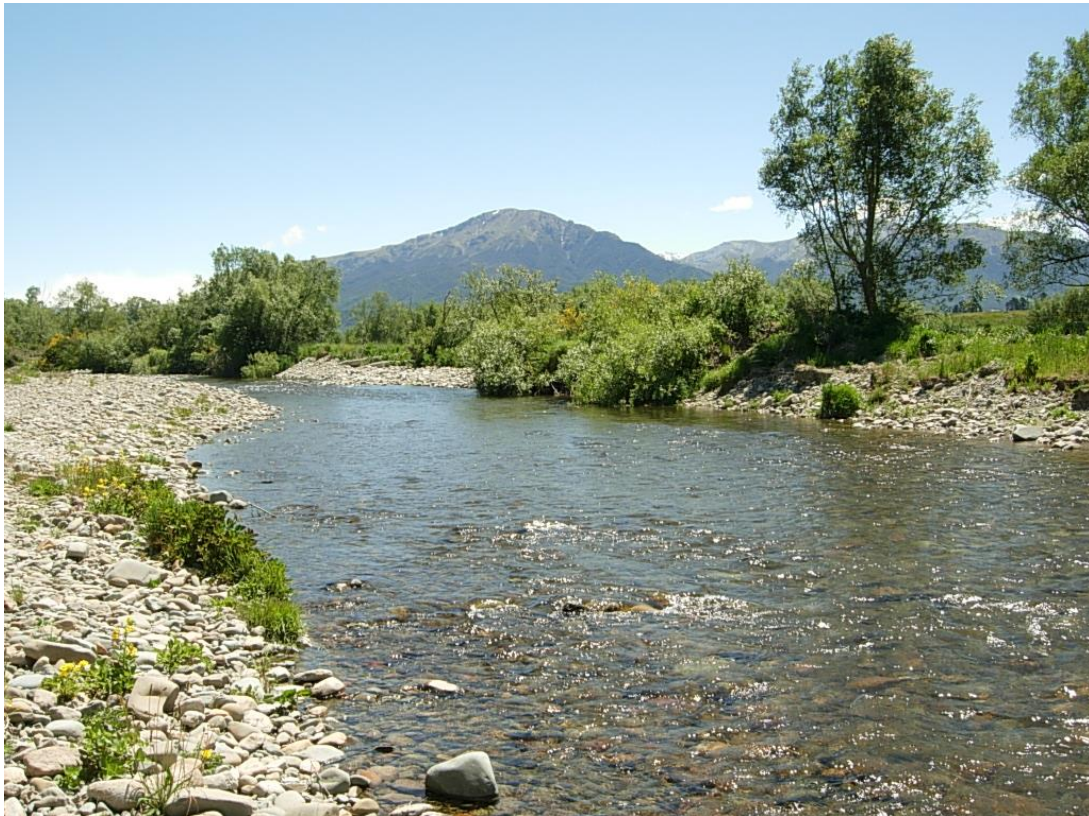
8. There used to be a large semi overhanging tree on the right bank on the right of the picture, removed during the work, leaving an exposed bank. The tree provided shade and stability, further up there used to be a pool where the gravel has been pushed into the side... you can just make out two logs, the next picture show that area close up after the floods

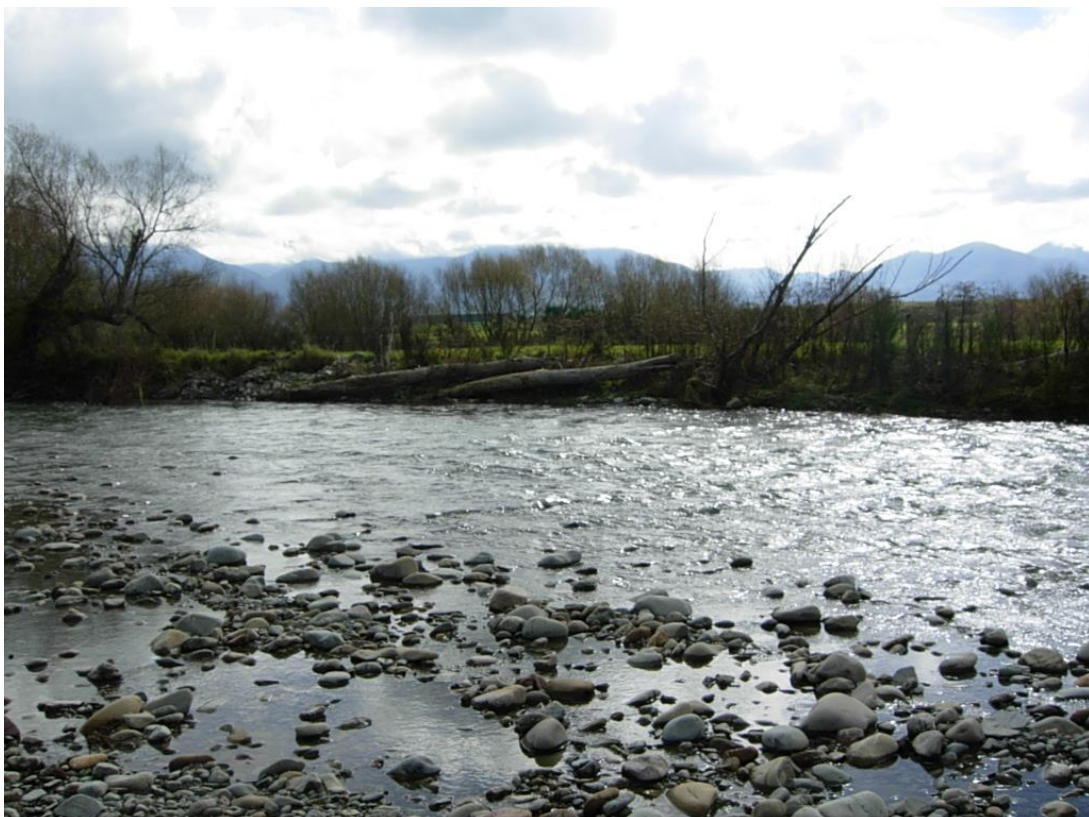
9

A close up showing how the work has been removed in the April floods, the logs were there previously

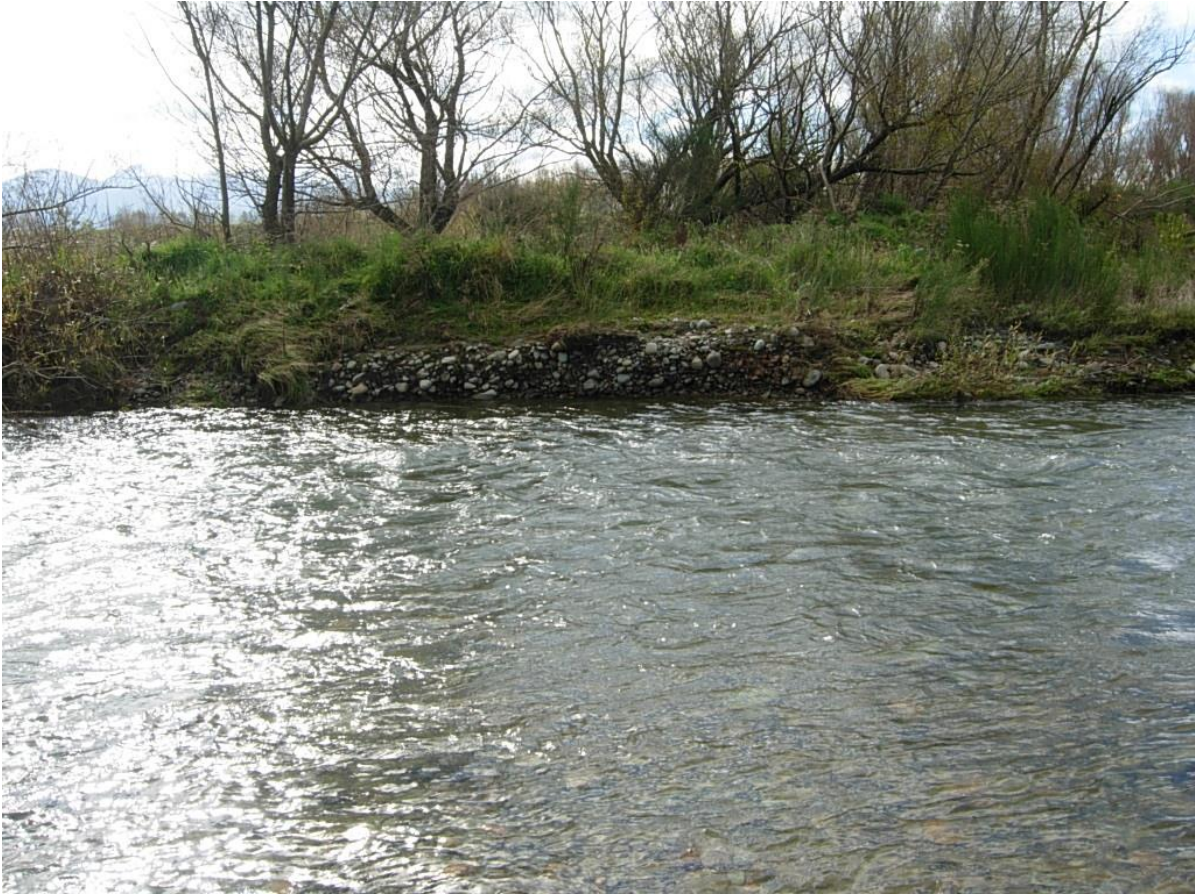
The same area again showing how the bank where the large tree was removed from has eroded (Right hand side of Pic No 8)

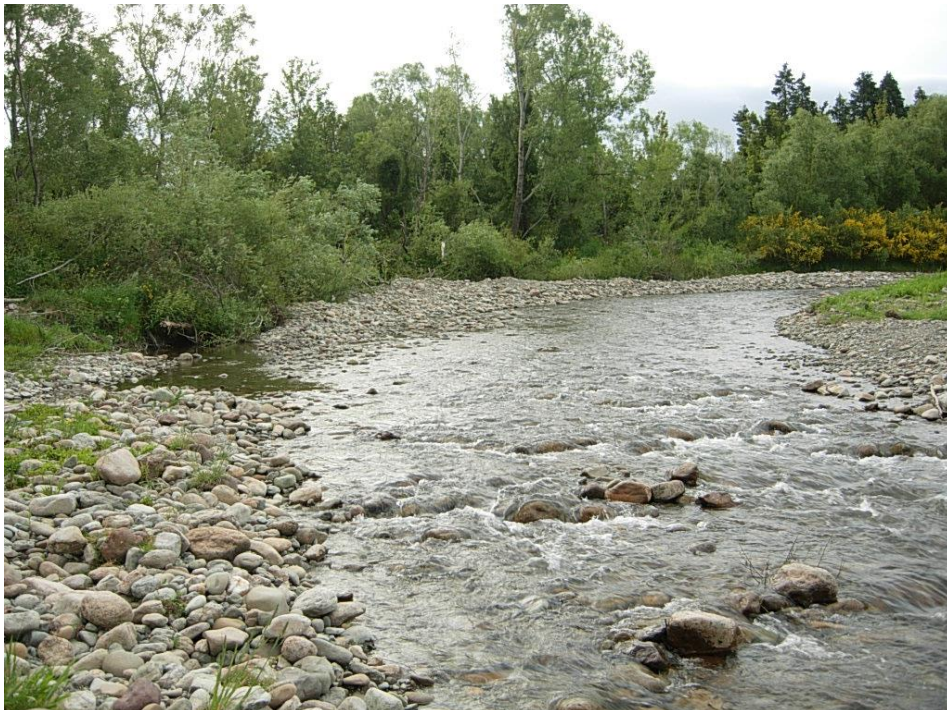
11. Pools removed, shading lost, trout habitat gone...

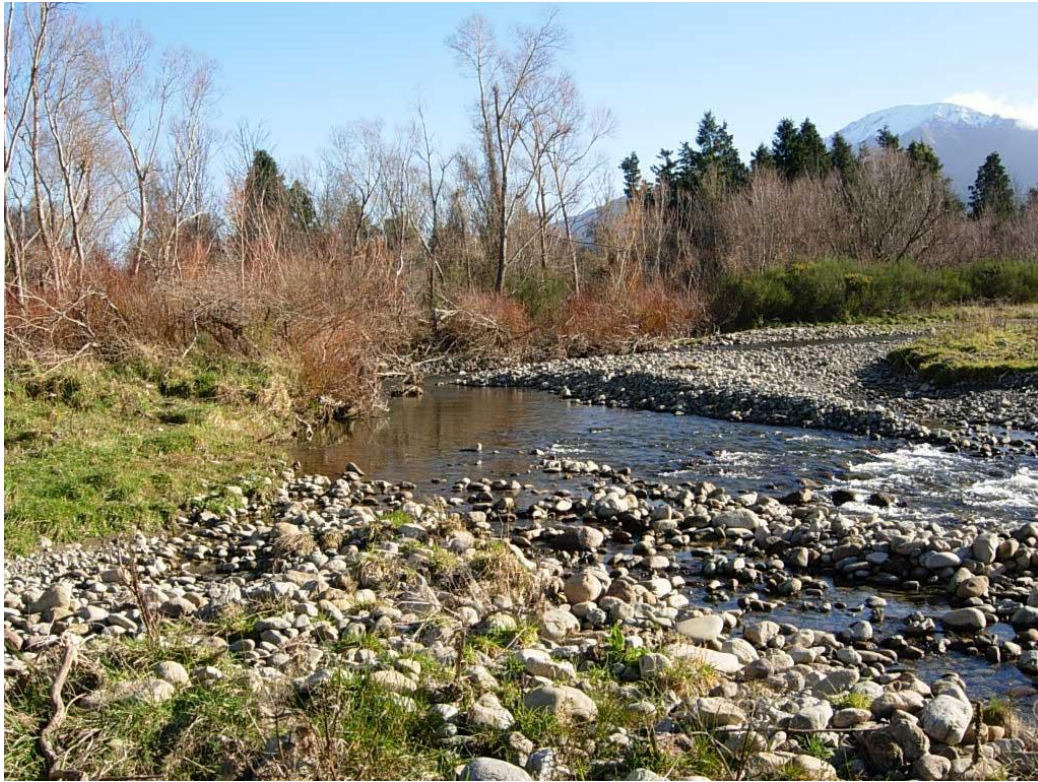
12 – Same view after floods. The gravel bank has be washed out, most of the stream is now flowing against the far bank, pool re-formed
